## North Shore Geo, PLLC

June 16, 2023

Subject: **GEOTECHNICAL REVIEW  
STATE OF WASHINGTON DEPARTMENT OF NATURAL RESOURCES (DNR)  
FOREST PRACTICES APPLICATION (FPA) NO. 2617912  
"PARCHED" TIMBER SALE  
CLALLAM COUNTY, WASHINGTON**

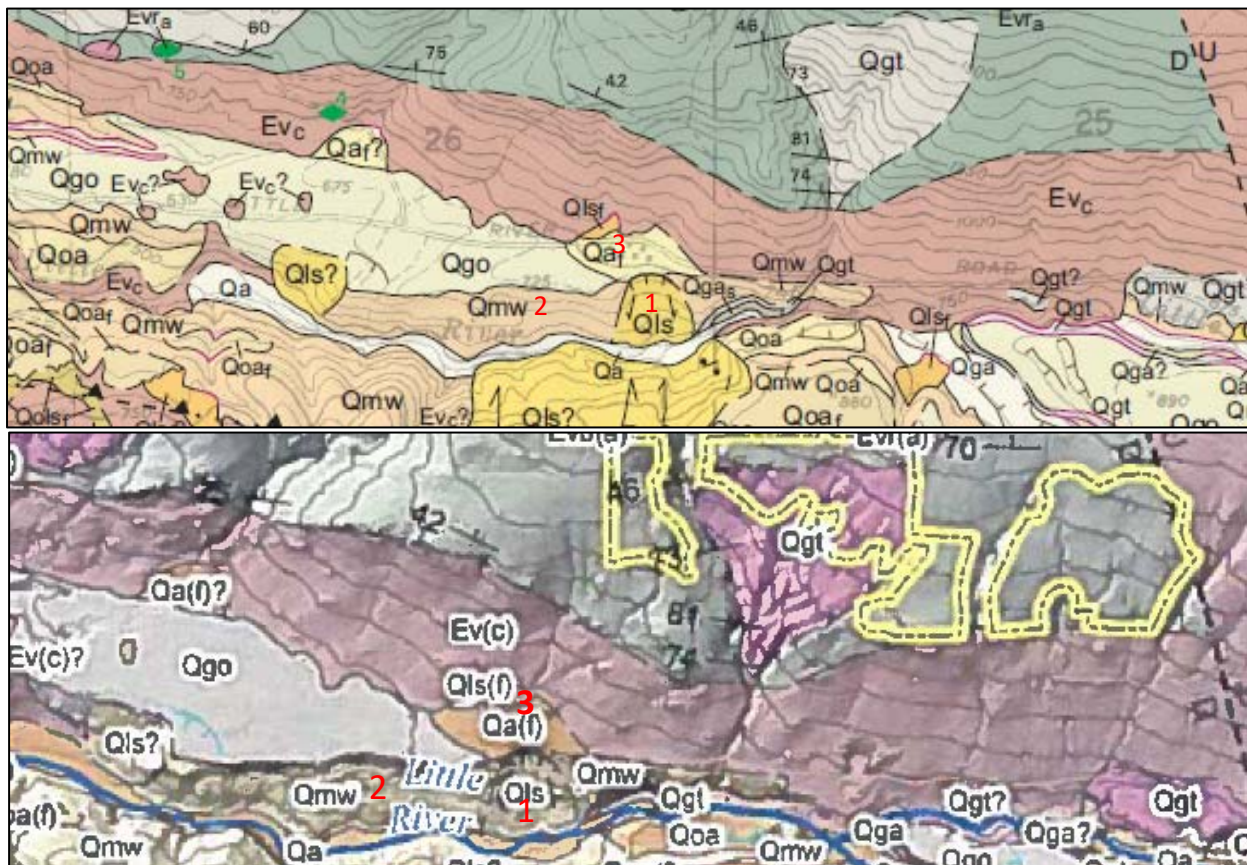
Figure-1: Geologic Maps with My Red Feature Numbers; Upper is Original and Lower is Fig. 1 of GMPH with Unit 1

1. Feature 1 (Red Number 1). I was only able to see this feature from Little River Road due to private property access restrictions. It is mapped as a Quaternary landslide (Qls, with relatively-high certainty due to lack of a question mark). This feature is consistent with a DSL, which is considered a RIL per the DNR Forest Practices. The GMPH discusses it on pages 2-4 and in Image 1. The GMPH concludes that less than roughly 20% of the feature from the geologic map is an active glacial DSL, and delineated a topographic groundwater recharge area (TGRA) which does not extend to Unit 1. The GMPH does not mention that the alluvial fan (Qa<sub>f</sub>) feature on the uphill / scarp side of the Qls contains a residential development which is associated with the recent (certainly since the time of timber harvest) road grades and land modifications (buildings are gray boxes). Active fault traces are mapped on the geologic map along the south edge of figure-1 and also roughly parallel to Little River Road (just west of the left edge of the image, but recent studies have extended east through the entire image as I show in my figure-4).

The limits of the Qls / DSL with my red number 1 for feature 1 is much easier to see on the upper image in figure-1 compared to the lower image in figure-1. In my figure-2 below (Fig. 3 of the GMPH), the DNR shows what they consider to be active glacial DSLs as light-yellow areas, with a blue dotted region as the corresponding TGRA for their reduced size (roughly 20%) of feature 1 / Qls / DSL. The larger orange outline area is my feature 1 / Qls / DSL on the geologic map with my very approximate TGRA outlined in light blue. The area northwest of the larger orange area and south of Little River Road is the residentially-developed area that also includes the private road which the DNR finds is responsible for the “deep-seated slump.” This road grade ascends the steep river bluff from the “slump” area near the river up to the northwest edge of the Qls / DSL / orange area. It appears to me that there are other DSLs in this bluff slope in the area of the private road. The DNR determination that the rest of the Qls / DSL / orange area is entirely “intact terrace” does not appear to me to be adequately supported by evidence and appears otherwise in light distancing and ranging (LiDAR) imagery. I discuss feature 2 and my very approximated TGRA (an official TGRA was not included in the GMPH) below my figure-3.

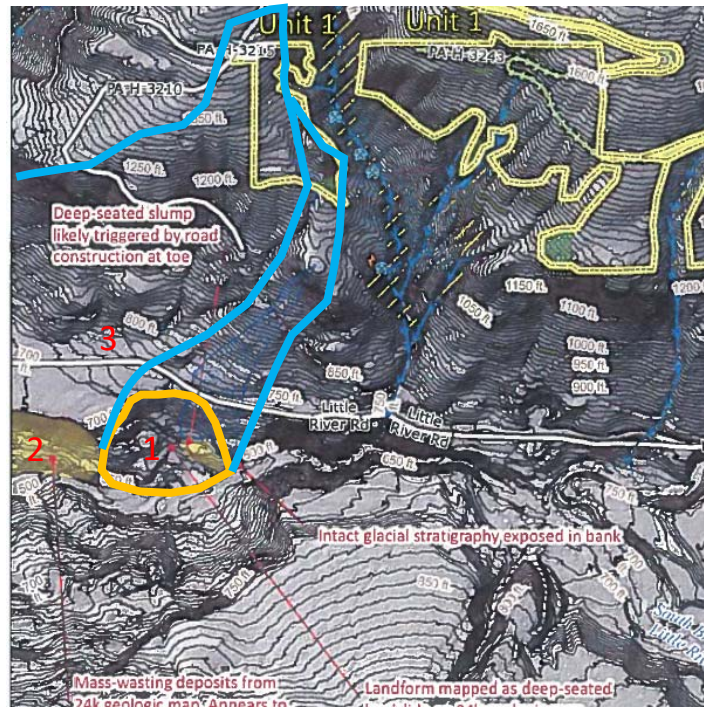
Figure-2: GMPH Fig. 3 with My Added Orange Outline of Geologic Map DSL / Qls and Light Blue Outline of Very Rough Estimate of TGRAs for Features 1 and 2

In my opinion it dramatically under-represents DSLs to map them the way that is typical of the State Lands DNR geologists: they map the DSL and delineate the TGRA for the deposit only, and do not include the scarp area. This is particularly problematic in marine and fluvial environments where the slide deposit is actively being removed, such as for these glacial DSLs in the Little River bluffs. This results in dramatically-undersized DSLs and TGRAs, and frequent omission of landslide areas in DNR reports.

2. Feature 2 (Red Number 2). I was not able to review this feature in the field due to private property access. This feature is visible as delineated by the DNR in my Figure-2 above (Fig. 3 from the GMPTH) and my rough approximation of the DNR’s delineation is shown above in my Figure-3. The GMPTH text does not mention this feature, but in its Fig. 3 is called out as: “Mass-wasting deposits from 24k geologic map. Appears to be deep-seated landslide in LiDAR.” The materials in this area appear to be glacial based on the geologic map, the GMPTH, and appear to be “active.” **As such, feature 2 is likely an active glacial DSL, which is a RIL, with a TGRA that is also a RIL. A TGRA for feature 2, which appears that it would include Unit 1 and at least one residential property, was omitted from the GMPTH.**

It appears to me that several scarps associated with this feature extend up onto the terrace and show significant displacement of the glacial terrace, implying that the area the DNR shaded yellow on their Fig. 3 should be enlarged significantly.

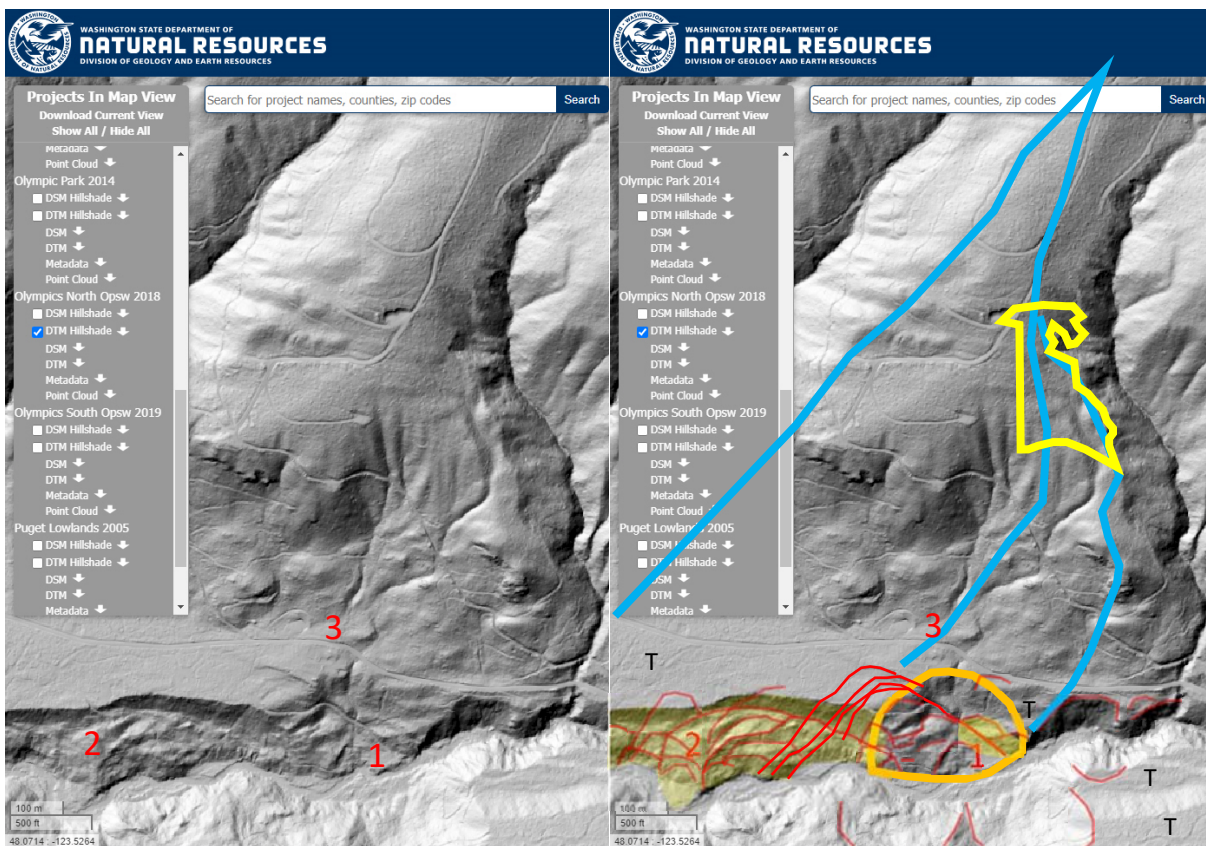
**Figure-3: LiDAR Imagery with Light Yellow DNR DSLs, Rough Yellow Unit 1 Outline, My Feature Numbers, My Landslide Scarps in Red, Orange Geologic Map DSL / Qs, Black Ts for Terraces, and Light Blue Outline of Very Rough Estimate of TGRAs**

My Figure-3 below is a comparison of “bare-earth” LiDAR from the DNR LiDAR Portal with my annotations. I find that these images from the DNR website provide a third look at this area in comparison to the two images on page 3 of the GMPTH, although the digital quality of the FPA PDF document is low and many features are difficult to see clearly. **Rather than finding the topography dominated by intact terraces as the GMPTH did, I find the terrain to be dominated by DSL activity** related to river scour and channel migration, and apparent groundwater-driven landslides in glacial or post-glacial sediments. I have included a black letter T in areas that appear to me to be intact terraces. In Figure-3 I have also approximated the locations of Unit 1, the DNR-identified glacial DSLs, landslide scarps, and TGRAs. The very dark shaded area east of feature 1 appears to be actively scoured by the River and appears to have potential to expand into the road. This feature appears as though the proposed timber sale would increase runoff and groundwater here, which would decrease stability. Instability here directly and adversely affects residences, Little River Road, and Little River.

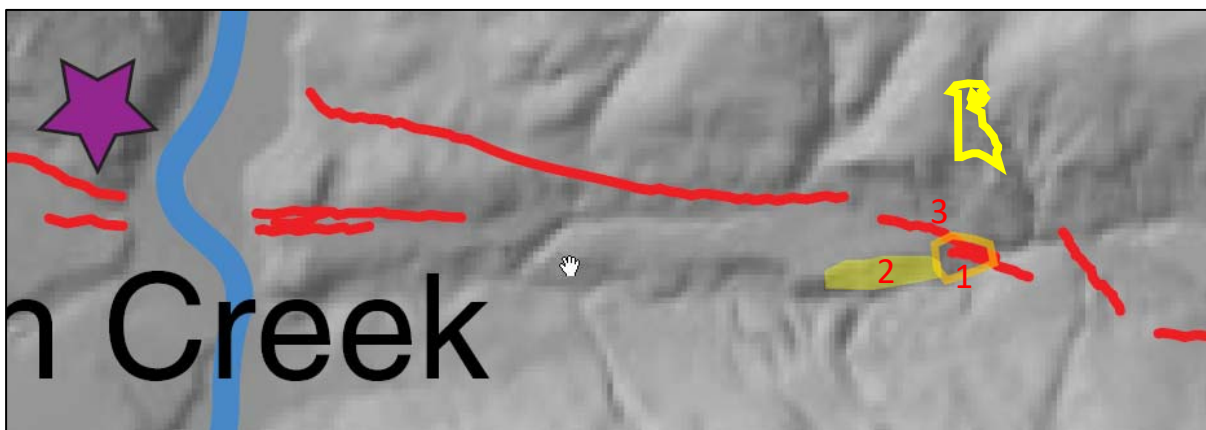
Figure-4: 2021 Fault Study Referenced in Aldwell EGRA with Red Fault Traces, My Hand at Quarry Location discussed in Aldwell FPA, Orange Feature 1, Yellow Shaded Feature 2, Yellow Outlined Unit 1, and Red Numbers for Features 1-3

**4. Active Faults.** The immediately-adjacent “Aldwell” timber sale (FPA 2617563) included an engineering geologic risk assessment (EGRA) report by the same author as the GMPH for the subject FPA, which included significant discussion of active fault traces (activity at 1, 3, 7, 8.5, and 11 thousand years ago with Magnitude 7-7.5 earthquakes) of the “North Olympic fault zone” or “Lake Creek-Boundary Creek fault.” The same 2021 reference from the Aldwell EGRA (*Elizabeth R. Schermer, Colin B. Amos, William Cody Duckworth, Alan R. Nelson, Stephen Angster, Jaime Delano, Brian L. Sherrrod; Postglacial Mw 7.0–7.5 Earthquakes on the North Olympic Fault Zone, Washington. Bulletin of the Seismological Society of America 2020;; 111 (1): 490–513. doi: <https://doi.org/10.1785/0120200176>*), and a 2019 reference (*Duckworth, Cody, "Slip and strain accumulation along the Sadie Creek fault, Olympic Peninsula, Washington" (2019). WWU Graduate School Collection. 896. <https://cedar.wvu.edu/wwuet/896>*) from the 2021 reference show active fault traces crossing my “feature 1” and my “Feature 3” discussed above and trace very close to the top of my “feature 2.” Figure-4 and figure-5 below include images from the 2021 and 2019 documents with my annotations. **The DNR did not discuss active faults in the GMPH and their presence within the discussed active DSLs.**

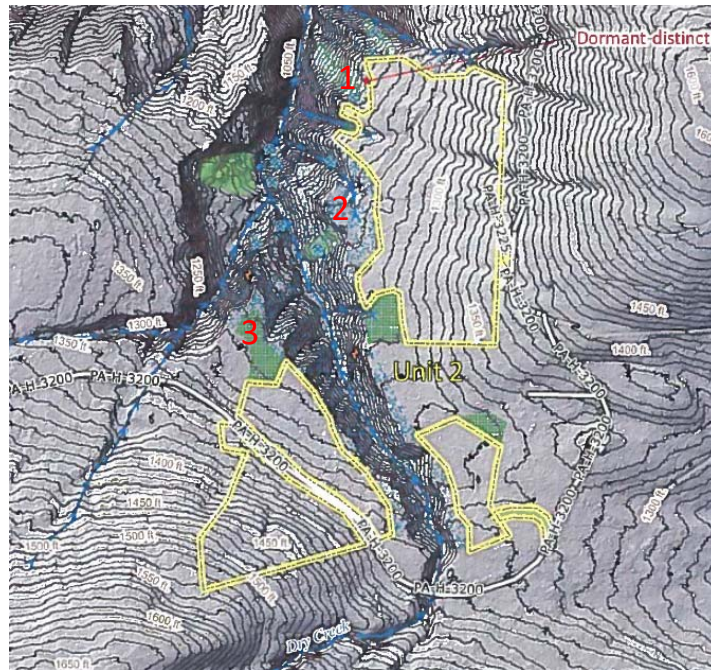
Figure-6: GMPH Fig. 4 with My Annotations

In Unit 2 I reviewed only the northwest and northeast portions in the field, including the Creek bluff slopes and adjacent upland areas. At the northwest corner of the northeast portion of the unit (marked with a red 1), I observed the bedrock DSL discussed on page 2 of the GMPH, including the old timber sale boundary markers on the body of this DSL which have been moved uphill to above the head-scarp. I do not understand the GMPH discussion here. The geologist would have approved harvesting part of the slide body and head-scarp, but the forester excluded it? If it was to be included in the sale, would the sale then be a type IV special? I agree that the head-scarp and upper part of the slide body appear dormant-distinct, but I would anticipate uphill-propagation of the Creek scour at the toe of this slide as category E or a potential for future instability. This DSL appears to have been caused by Creek scour at the toe and groundwater, both of which will be increased by this FPA. The FPA activity map shows a strange overlap of the riparian management zone (RMZ) graphic onto the harvest area that is inconsistent with the GMPH harvest boundary that should be edited.

The area of my red number 2 which is a broad wetland with minimal timber appears to also be a large DSL, with the ridge between the wetland / type 4 stream being the slide block. This slide appears to also be a bedrock DSL, which eliminates the delineation of a TGRA and the harvest boundary would remain in its current location. Timber harvest east / uphill of this area will add major additional surface and groundwater to this area, which will certainly increase erosion in the streams and instability of the stream bluffs, but the forest practices rules allow this.

The LTA on the north edge of the northwest portion of Unit 2, where my red 3 is located, appears to avoid harvesting this narrow ridge between very steep and unstable Inner Gorge and shallow landslide slopes. The shallow landslide (lightning symbol) appears to be on the west side of this ridge. I interpret the east-facing slope adjacent to the shallow landslide to be a DSL. The RMZ in this area seems minimal.

This LTA has experienced major windthrow that appears associated with the recent harvest of the area immediately to the west. The south, east, and west edges of this LTA appeared very wet at the time of my field review, with standing water and saturated, soft soils. There appears to be a north-flowing stream(s) from several culverts in the PA-H-3200 road through a recent harvest area west and south of this LTA through the LTA to these very steep bluff slopes. These conditions appeared similar to wetland conditions and may have contributed to windthrow in this area. The LTA at the northwest corner of the west edge of the unit appears to be covering some very borderline harvest area which appears as though more of it should be bound out of the sale rather than considered an LTA.

- Dormant-distinct DSL / feature 1: explain the discussion of this in GMPTH and clarify the timber sale boundary between FPA maps.
- Northwestern LTA / feature 3: review this area for streams and windthrow hazard in very wet soil conditions, consider the narrow area between shallow landslides, wet soil windthrow, DSLs, and RMZs to be bound out rather than LTA.
